S-22 Old Bank of Somerset Princess Anne private c. 1884

HISTORIC AMERICAN BUILDINGS SURVEY
INVENTORY

2. NAME Old Somerset Bank s-22

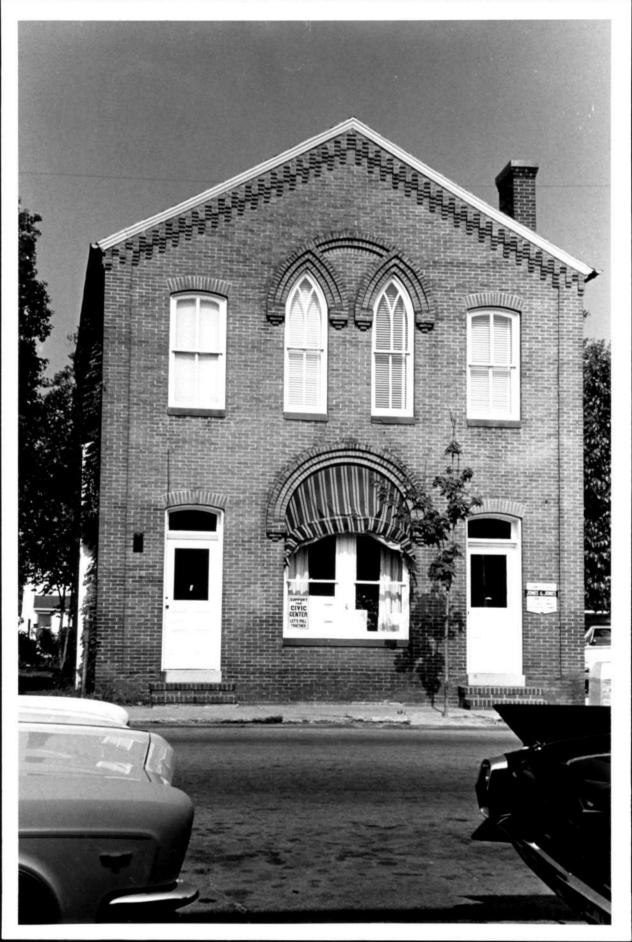
Jd Someset Bonk

The building is three bays wide. The 1st floor has a large central window with a rounded arch flanked on either side by doors with segmented arched frames. The central window is surrounded by an arch composed of three rows of recessing brick, ending in brackets of molded brick. The 2nd storey has a segmented arched window above each door. The central window on the 2nd floor is cut into two pointed Gothic windows surrounded by brick frames. All this is surrounded by the arched brick frame like the one on the first floor.

There are pilasters of brick on the corners of the building. The roof cornice is faced with brick brackets.
